Dewlish PWS: Impact on Devil's Brook

Presentation by Wessex Water
Ian Colley and Christopher Tattersall
27 February 2023

AMP6 Devil's Brook investigation

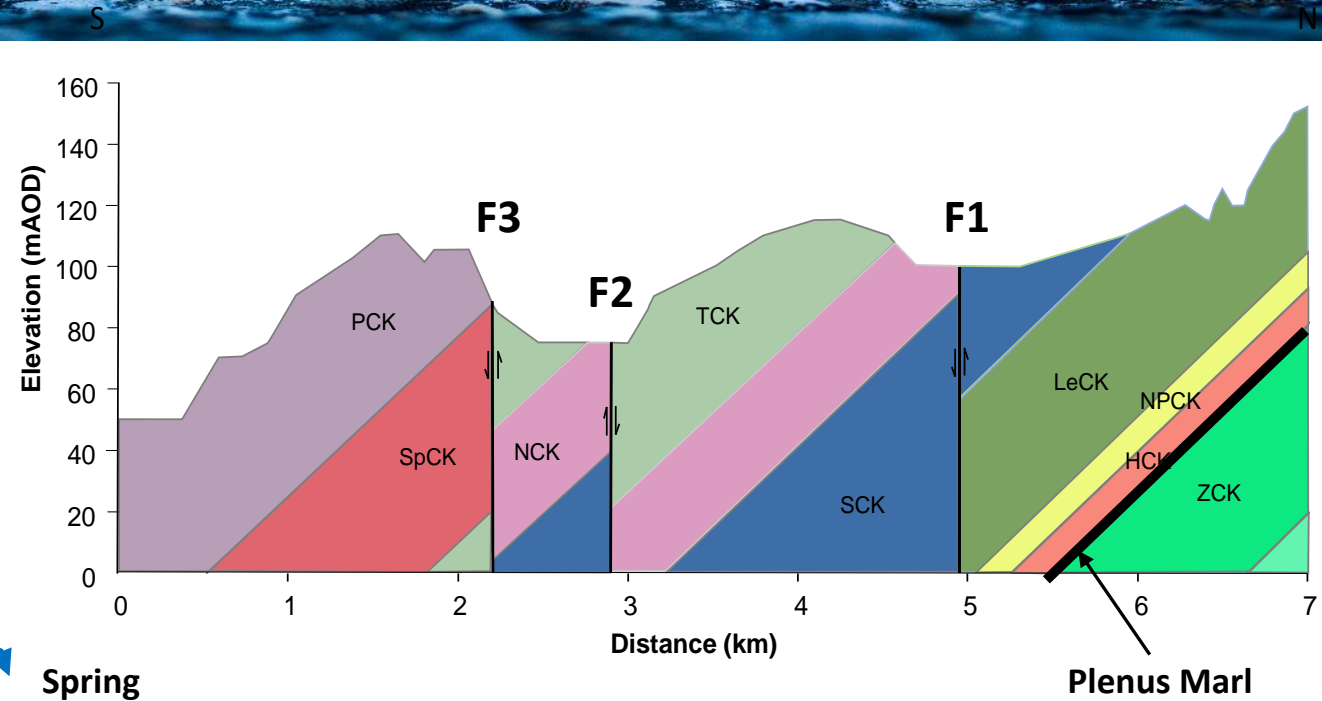
Geology

Spring

-   PCK – Portsdown Chalk Formation
-   SpCK – Spetisbury Chalk Member
-   TCK – Tarrant Chalk Member
-   NCK – Seaford and Newhaven Chalk Formation
-   SCK – Seaford and Newhaven Chalk Formation
-   LeCK – Lewes Nodular Chalk Formation

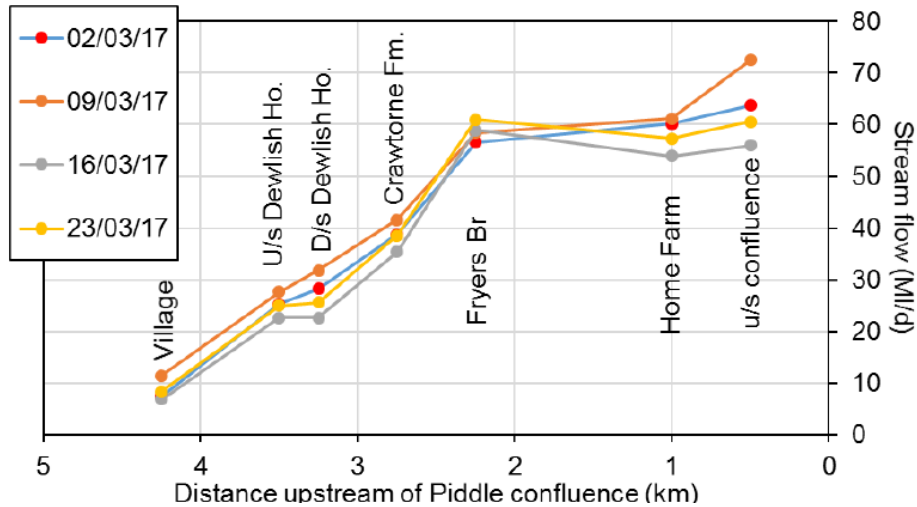
High flows

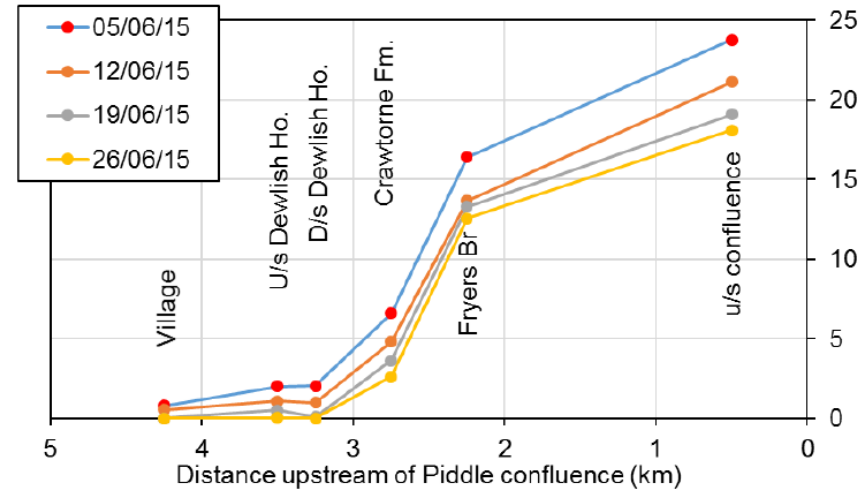
Medium flows

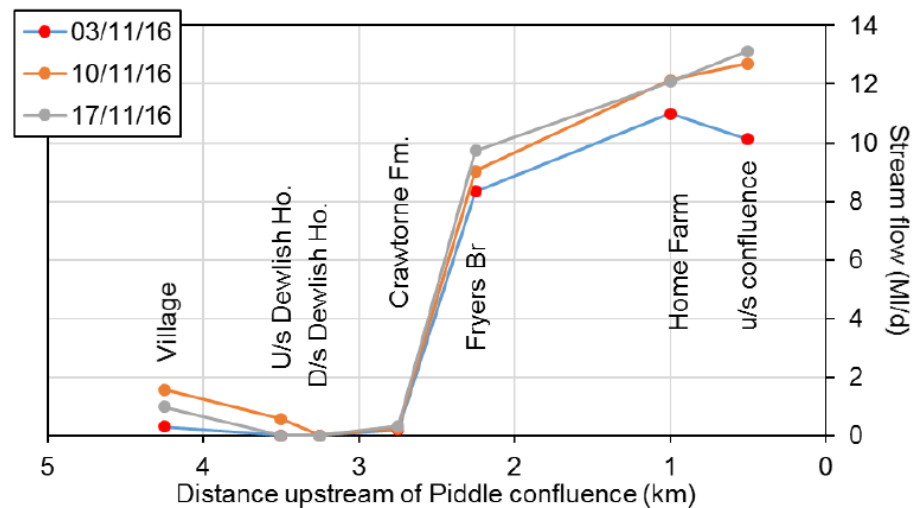
Low flows

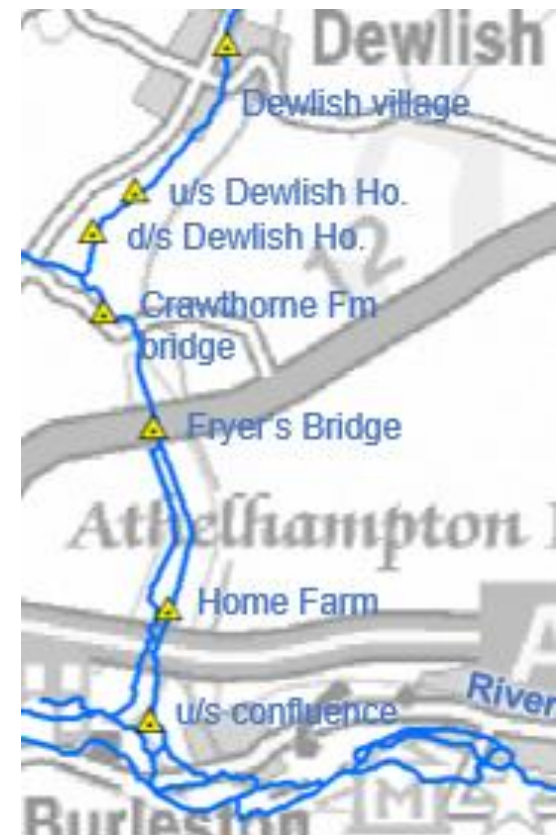
Flow gauging sites

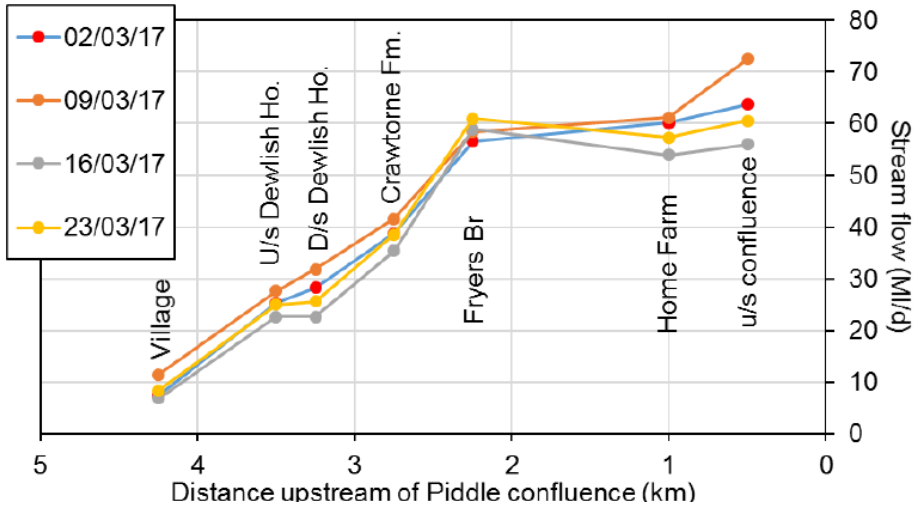
High flows

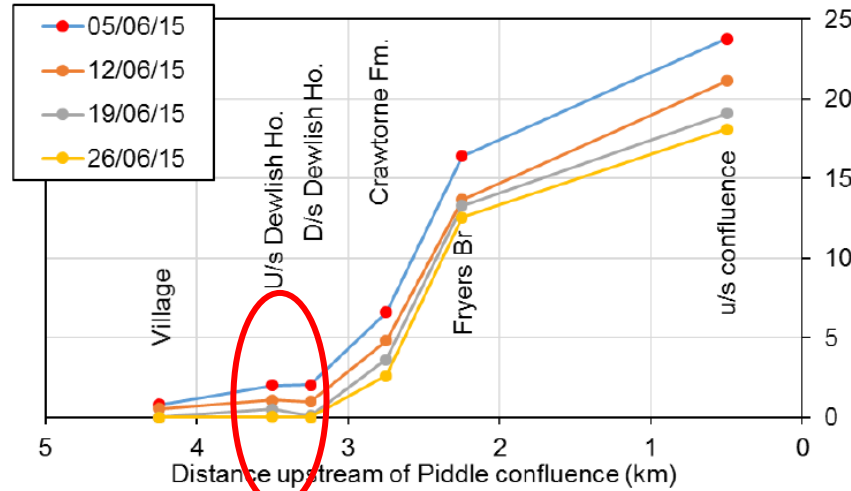
Medium flows

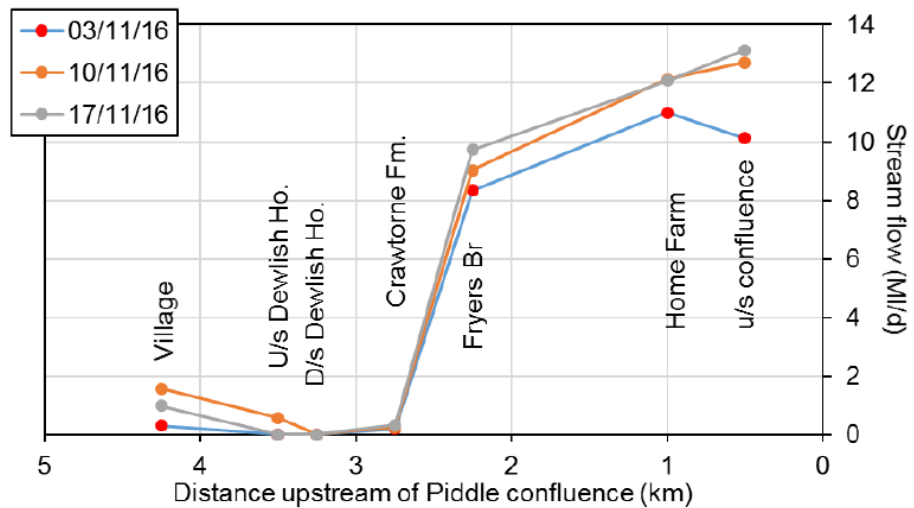
Low flows

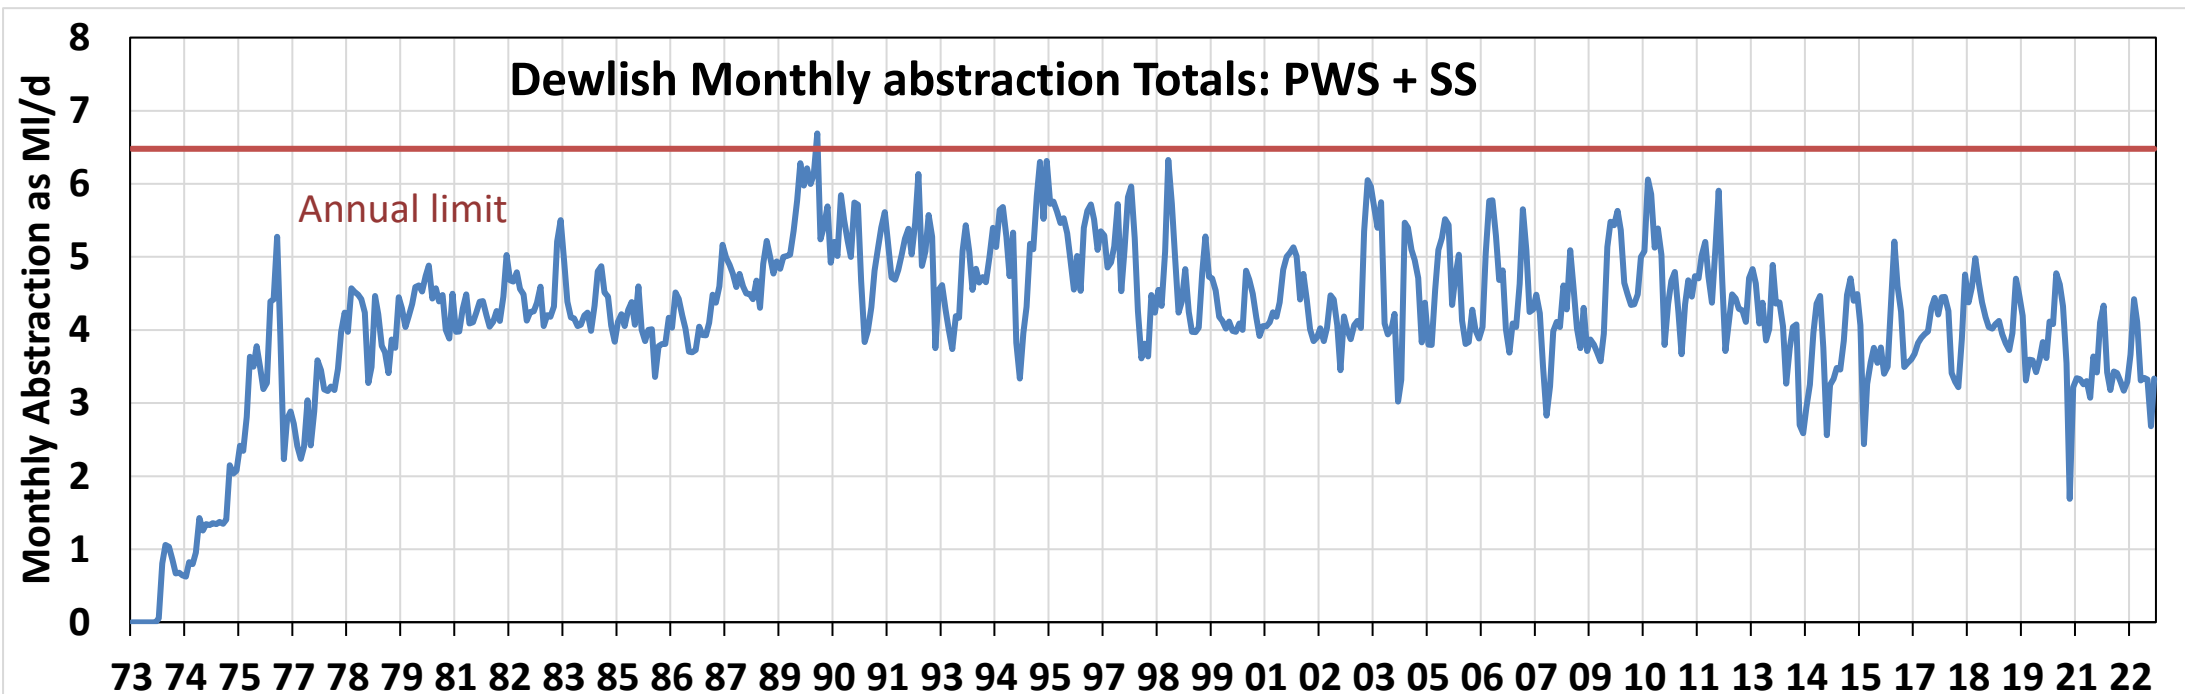
- Developed in the late 1960's
- Stream support used to mitigate impact
- Operational since 1973: 9.09 MI/d (PWS+SS)
- Annual 2363.966 MI (=6.48 MI/d)

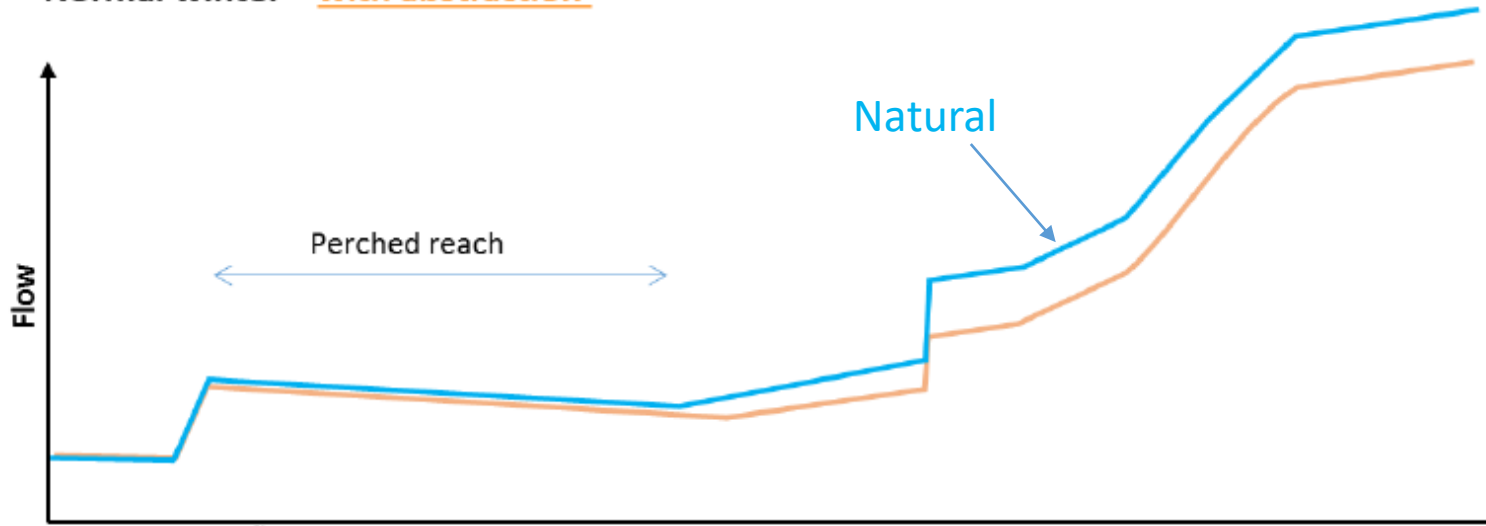
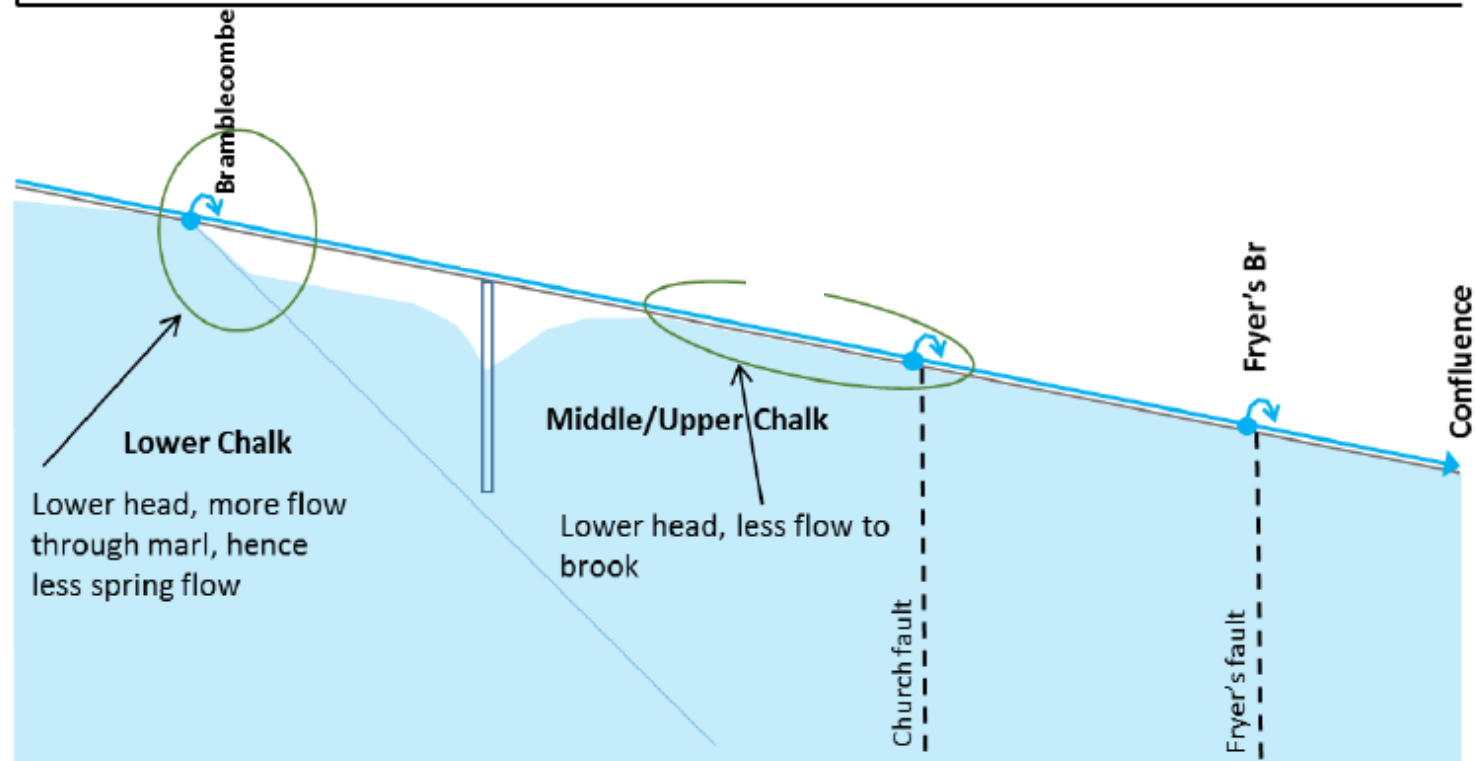
Normal winter – with abstraction

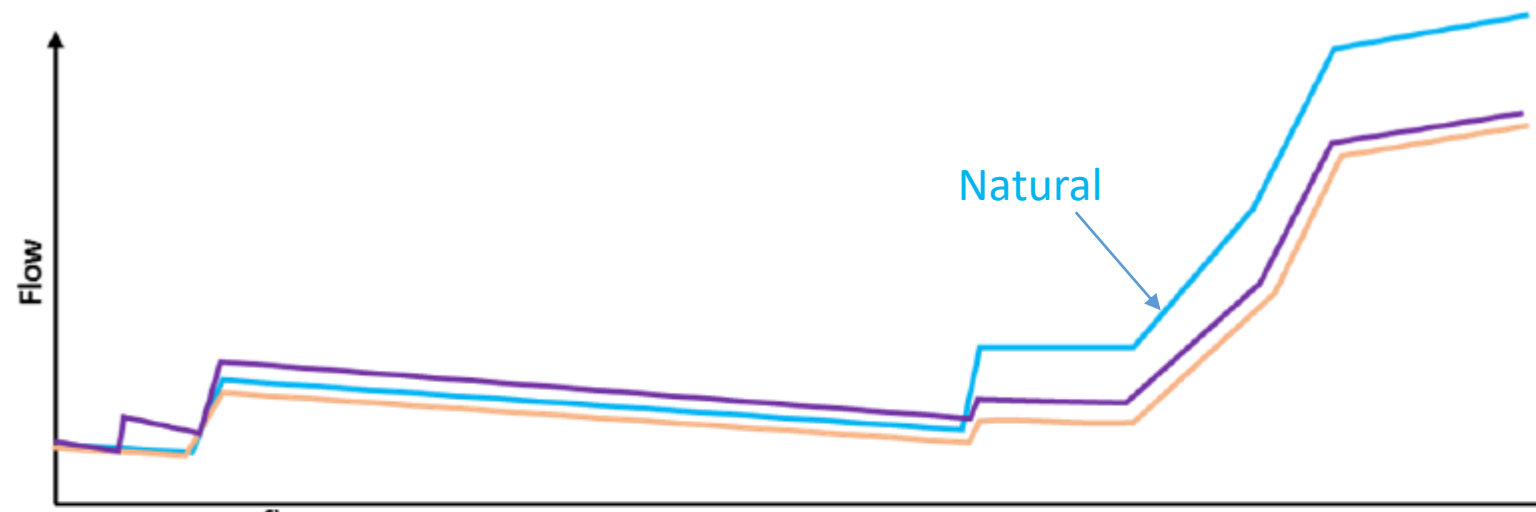
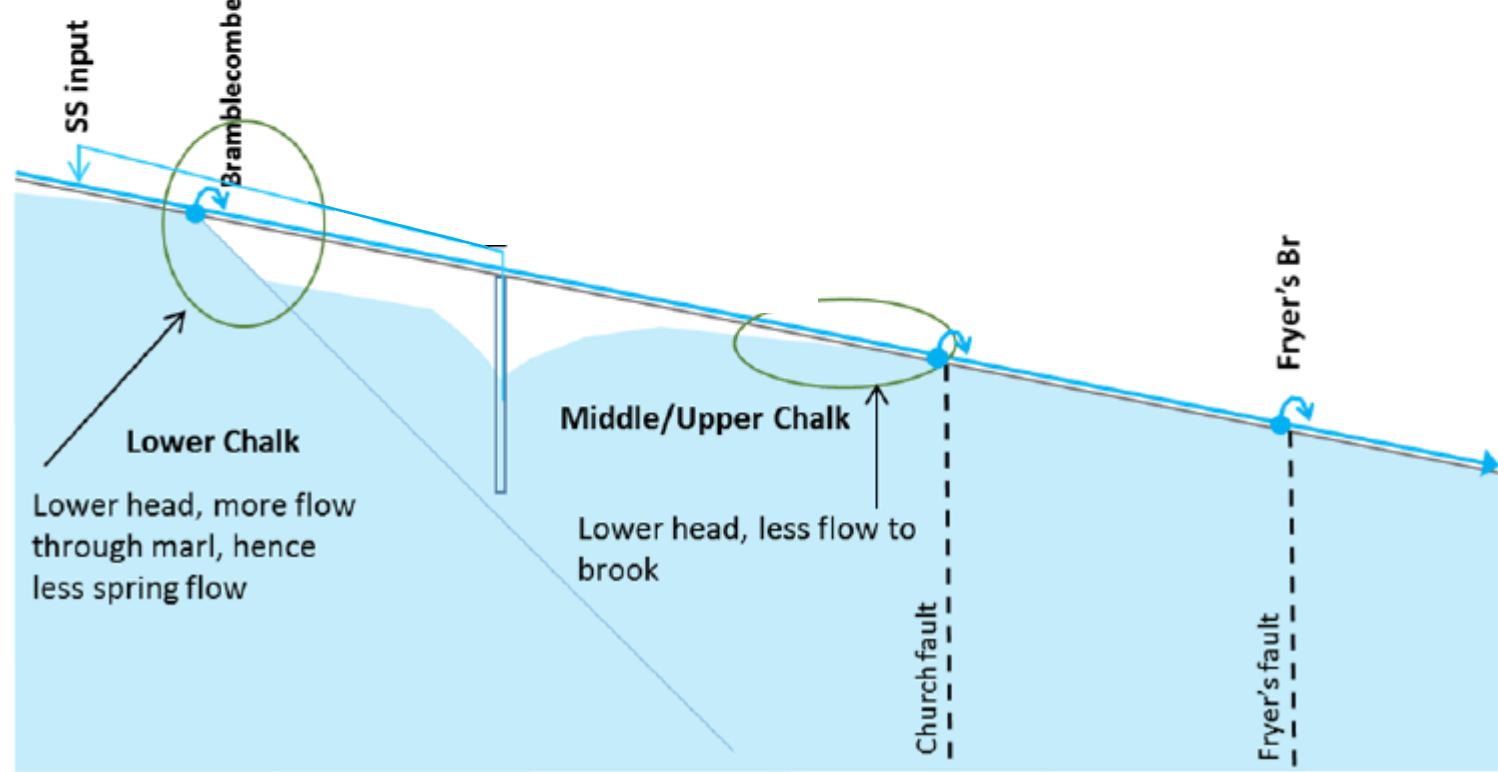
Spring – with abstraction and with mitigation

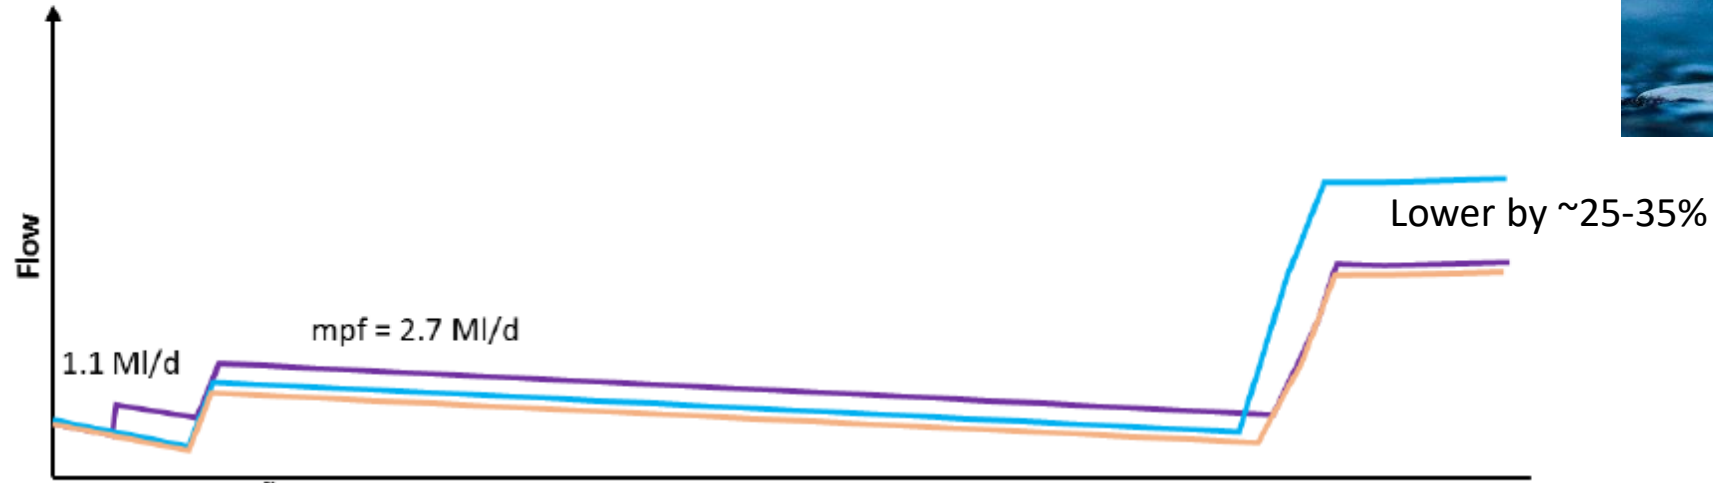
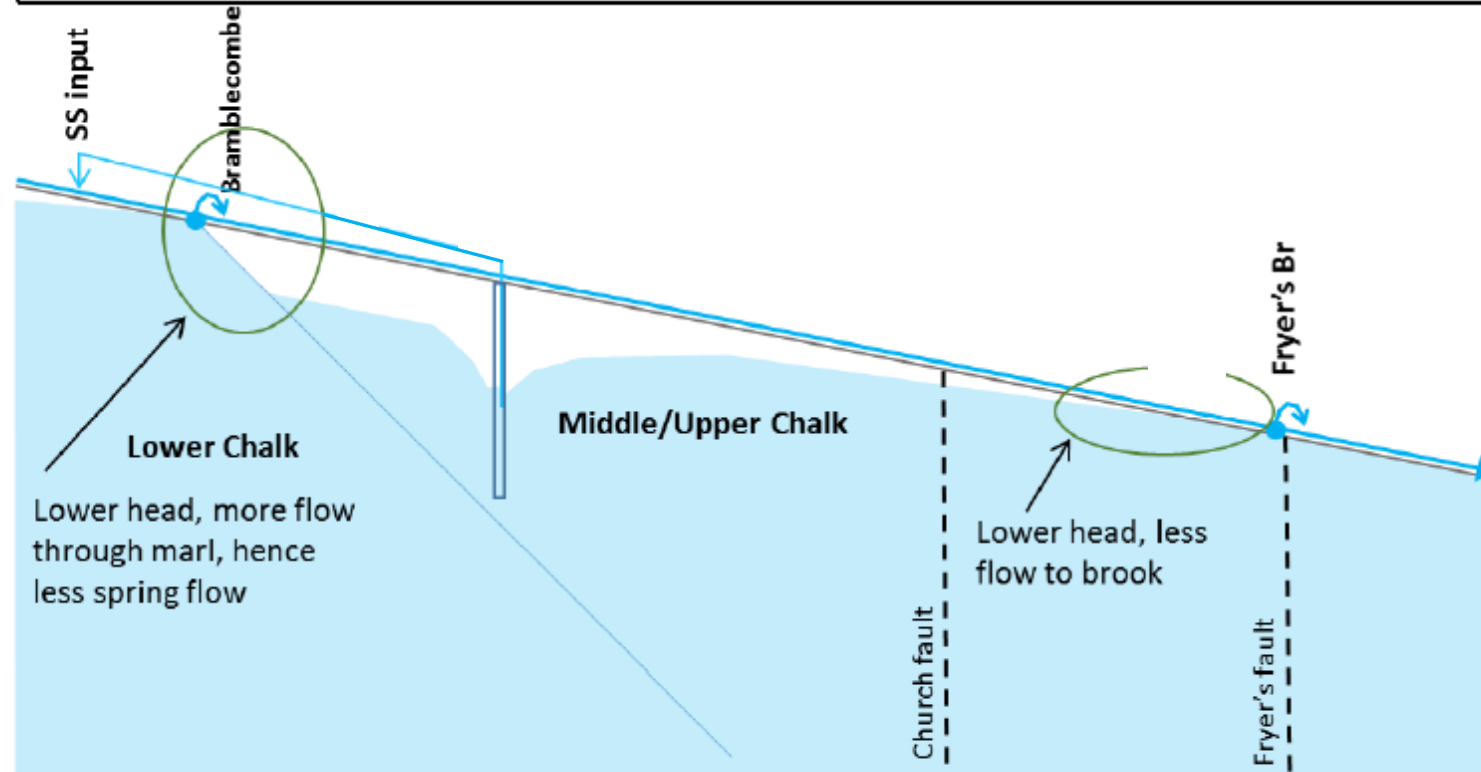
Summer – with abstraction and with mitigation

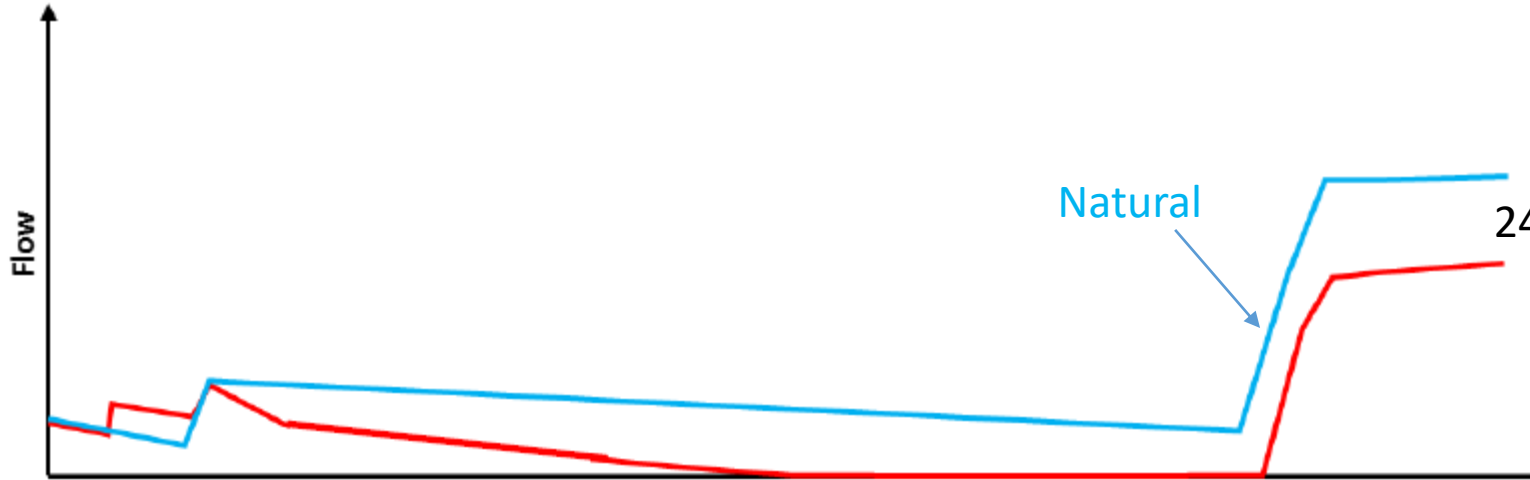
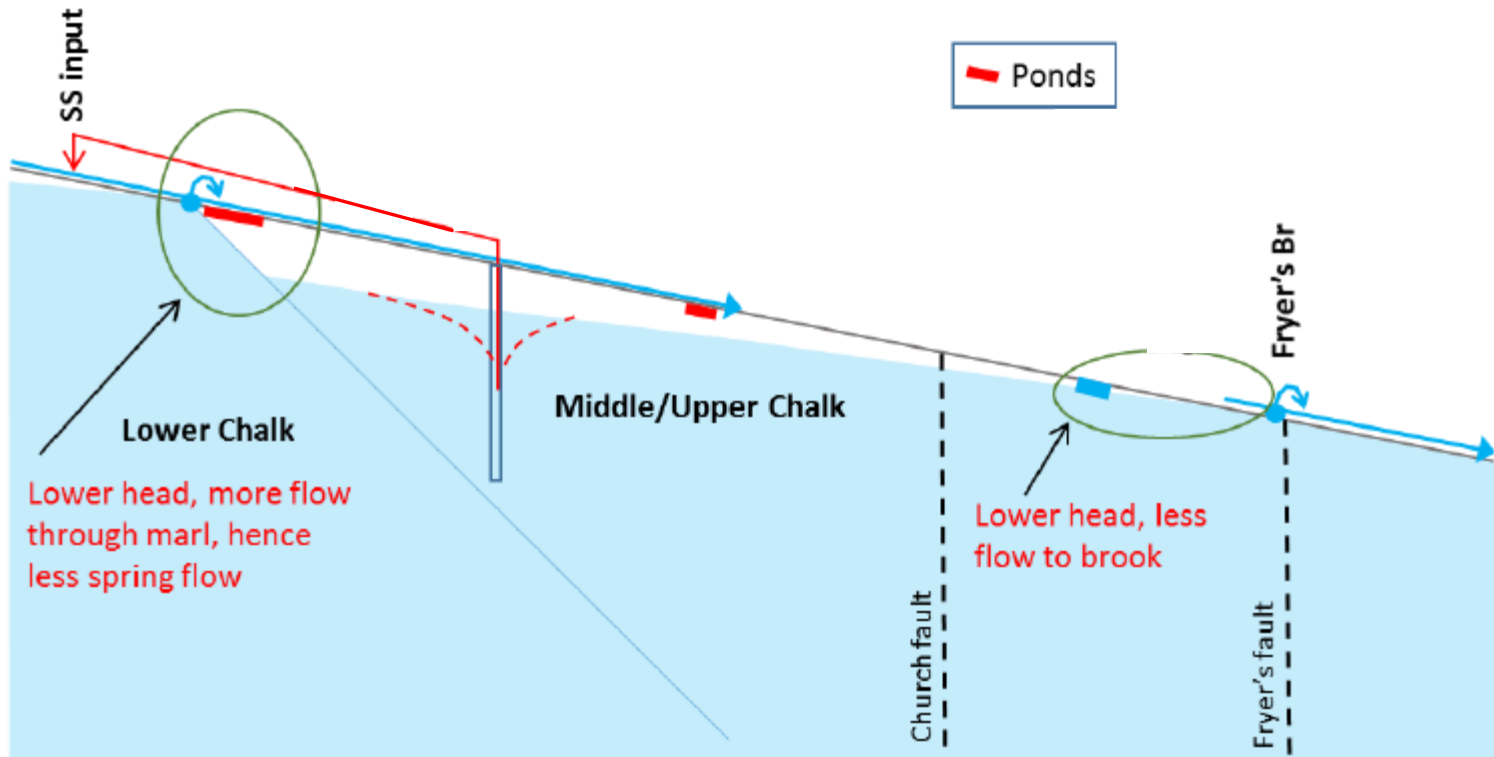
Summer Pre1972 and Post 1972

24% lower Recent Use : 35% at full licence

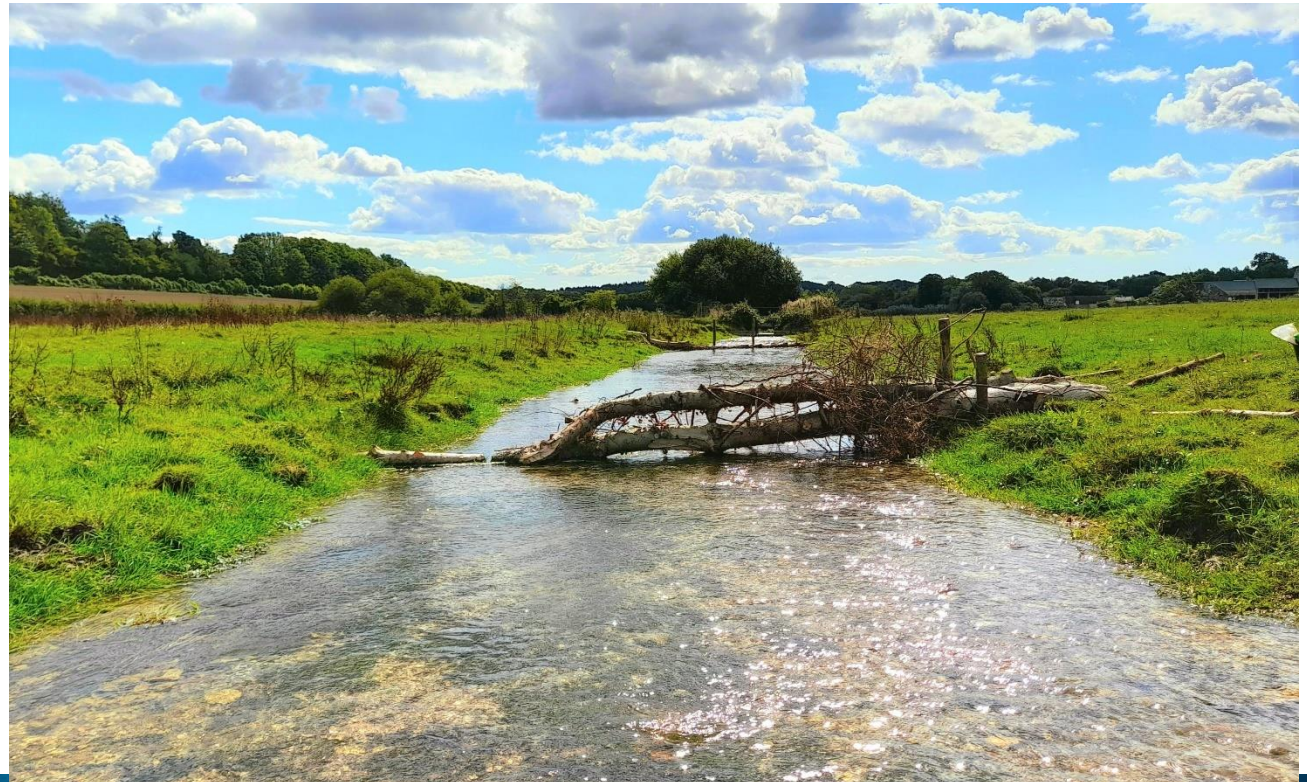
- Pending licence change
 - Summer total (PWS and SS) to be limited to 6.09 MI/d, down from 9.09 MI/d
 - Effectively limits summer PWS to 5 MI/d
- River habitat improvement – downstream of Crawthorne
 - Installed autumn 2022
 - Deflectors
 - Fencing

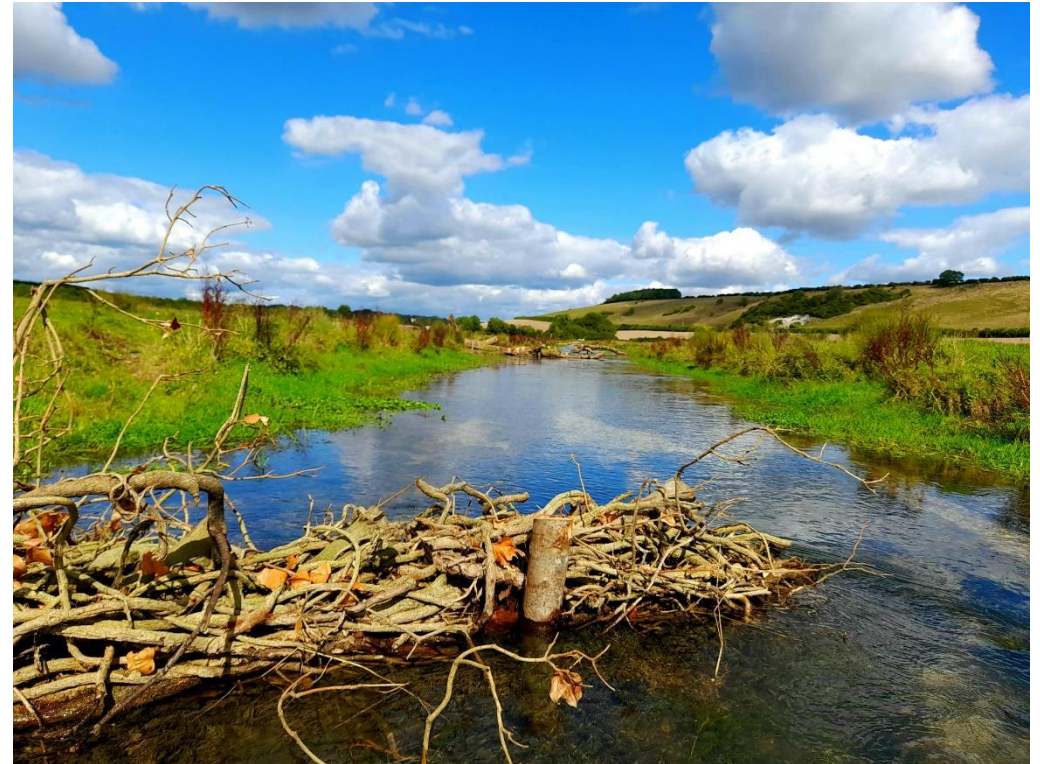
- Pending licence change
 - Summer total (PWS and SS) to be limited to 6.09 MI/d, down from 9.09 MI/d
 - Effectively limits summer PWS to 5 MI/d
- River habitat improvement – downstream of Crawthorne
 - Installed autumn 2022
 - Deflectors
 - Fencing
